Manhole Inspection Summary

Manhole # S35C1_012MH

Location Address: **2525 insulator drive**

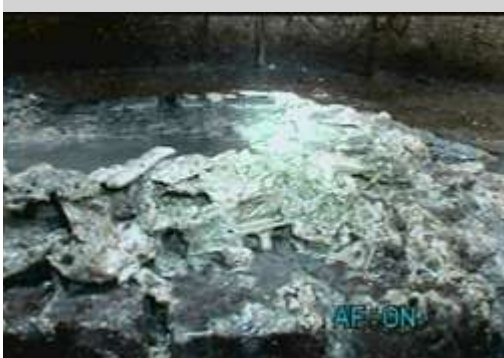
Defect 3

Condition: ☐ Sound ☐ Cracked ☐ Root Intrusion ☐ Deteriorated ☐ Leaks ☒ **Debris**

bench debris

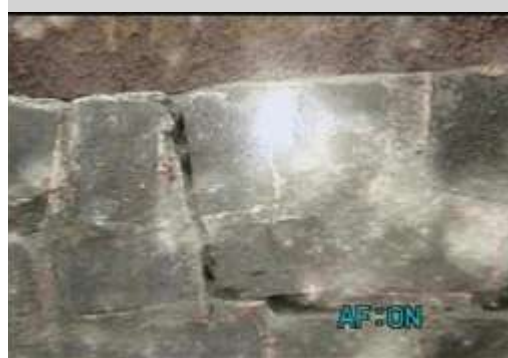
Defect 2

Condition: ☐ Sound ☒ **Cracked** ☐ Root Intrusion ☐ Loose Brick ☐ Deteriorated

chimney cracked, frame adj

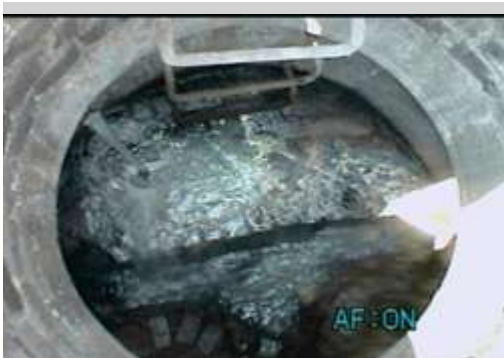
Defect 1

Count: **3** Missing: **0** ☒ **Corroded**

steps

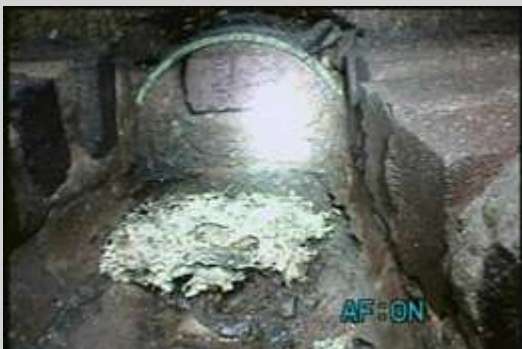
3 O'Clock Inflow

sealed
